Williams Inspection Services, Inc.
1425 Century Drive, Suite 101
Carrollton, Texas 75006
Ph. 972-245-2899, Fax 972-245-3463

Property Inspection Report

11/22/06
(Date)

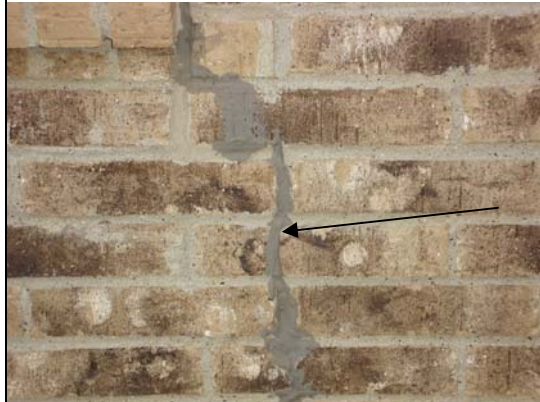
- ✓ There are separated caulk joints around the window boxes on the South side of the house.
- ✓ The frieze board has separated from the brick on the South side of the house near the front entrance.
- ✓ Prior repair to brick and mortar cracks on the East and West sides of the house.
- ✓ There is separated caulk at the joints between brick veneer and wood siding at the front entrance, and the East and West sides of the garage.
- ✓ There are exposed nail heads in the siding on the East side of the garage. It is recommended that these be covered with appropriate materials to prevent rust and deterioration.

Further evaluation and or repair is advised.
